Update "With-Site-Visit" Reserve Study

Talking Rock Ranch Association Master Prescott, AZ

Report #: 14573-2

Date Prepared: March 24, 2018

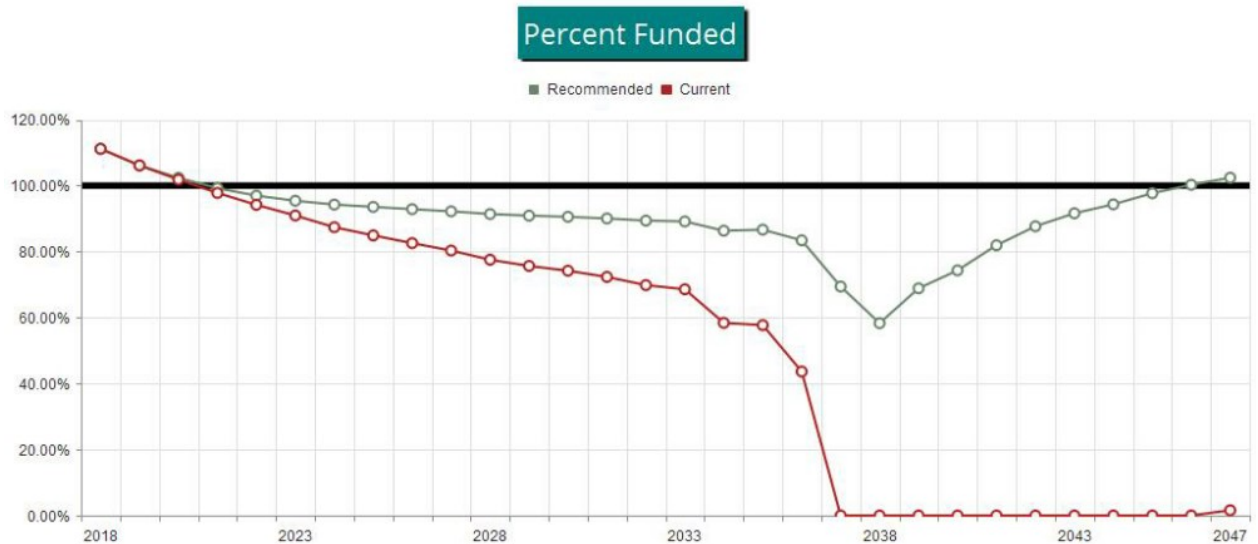
Figure 4

This chart shows the same information plotted on a Percent Funded scale. It is clear here to see how your Reserve Fund strength approaches the 100% Funded level under our recommended multi-year Funding Plan.

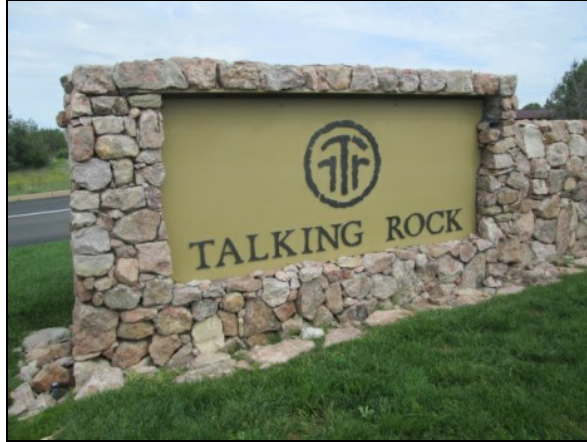
Useful Life:
15 years

Remaining Life:
13 years

Best Case: \$ 9,400

Worst Case: \$ 11,000

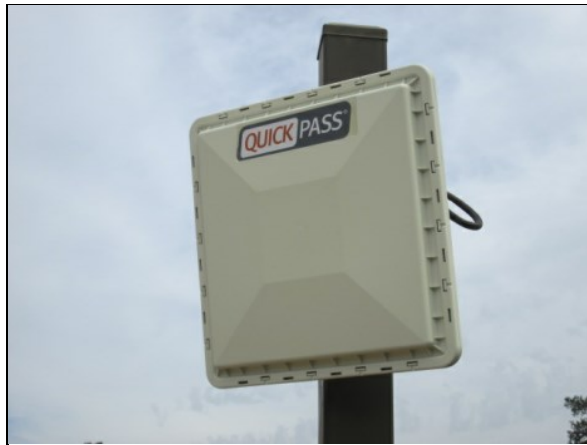
Useful Life:
10 years

Remaining Life:
7 years

Best Case: \$ 6,000

Worst Case: \$ 7,000

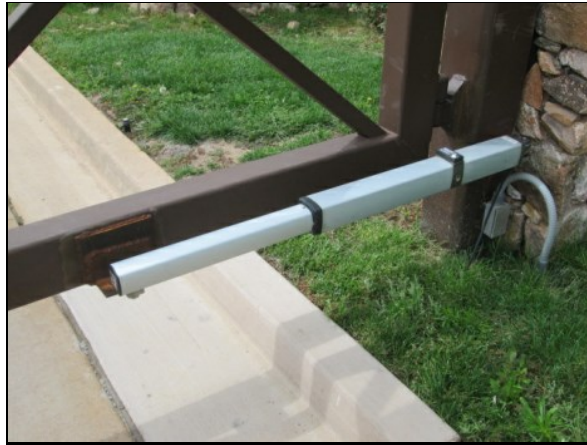
Useful Life:
12 years

Remaining Life:
9 years

Best Case: \$ 5,000

Worst Case: \$ 6,100

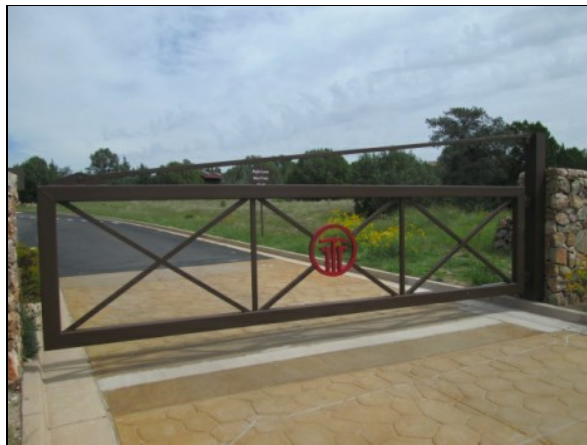
Useful Life:
30 years

Remaining Life:
27 years

Best Case: \$ 8,000

Worst Case: \$ 12,000

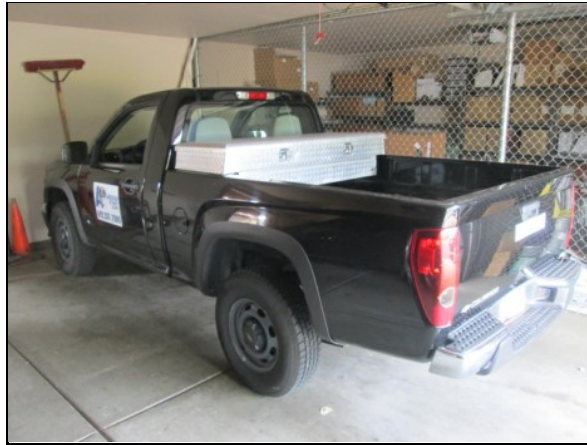
Useful Life:
10 years

Remaining Life:
2 years

Best Case: \$ 20,000

Worst Case: \$ 26,500

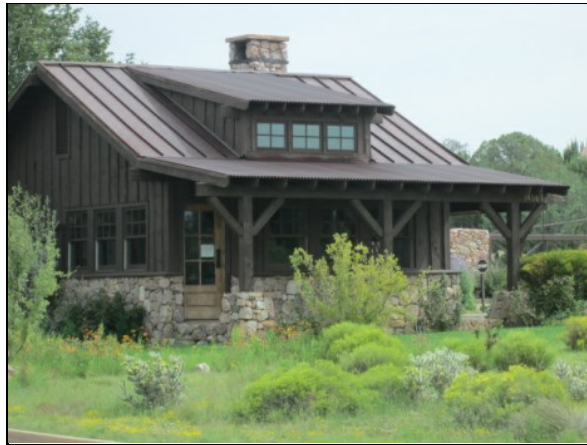
Useful Life:
40 years

Remaining Life:
25 years

Best Case: \$ 78,000

Worst Case: \$ 95,000

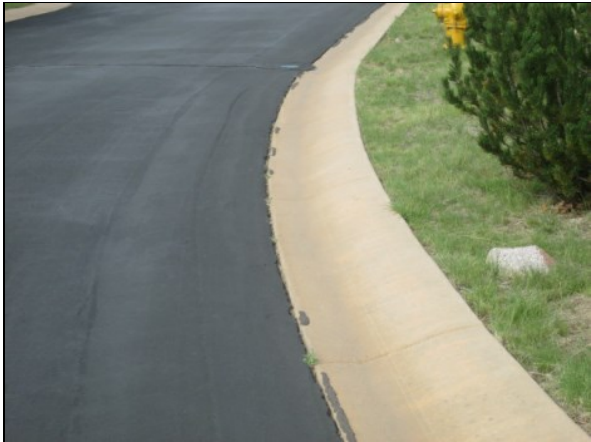
Comp #: 103 Concrete - Repair

Evaluation: There is no expectancy to completely replace the concrete. This component funds an allowance for periodic repairs and/or partial replacements.

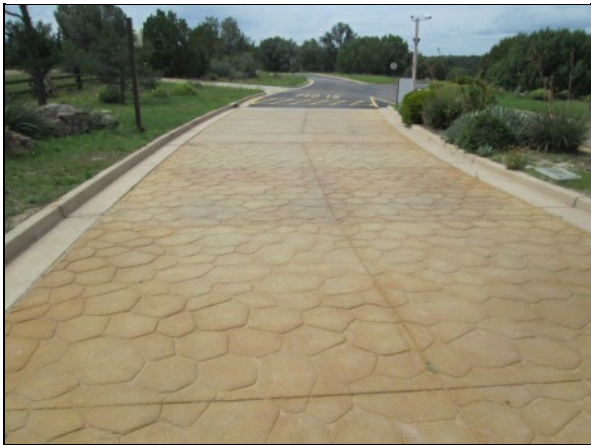
Comp #: 120 Concrete Drive - Replace

Evaluation: Entry lanes have a combination of stamped and smooth concrete. Decorative and in good condition. A few stains noted with some minor cracks. HOA should be prepared to eventually replace this concrete when cracking becomes widespread to restore the appearance.

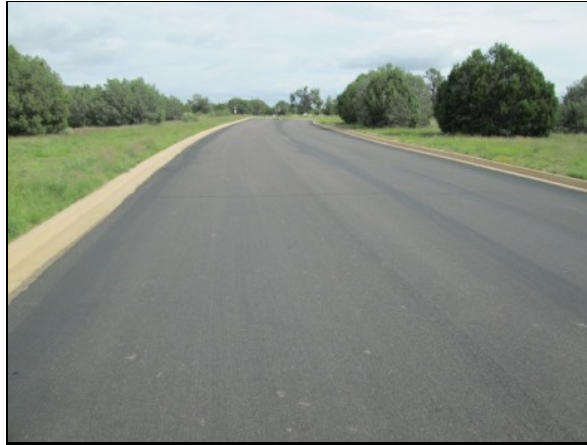
Evaluation: This is one of the main arterial roads in the community. Some larger cracking visible. Life span is based on periodically sealing and maintaining the surface.

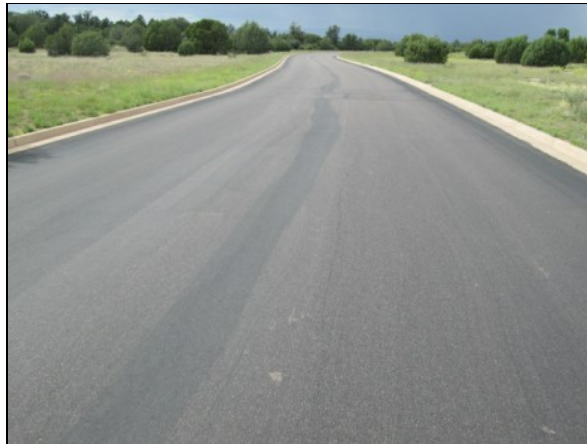
Comp #: 201 Asphalt - Seal/Repair (TR)

Evaluation: Seal coat looks old and worn down. Timing of the last application for this road is unknown.

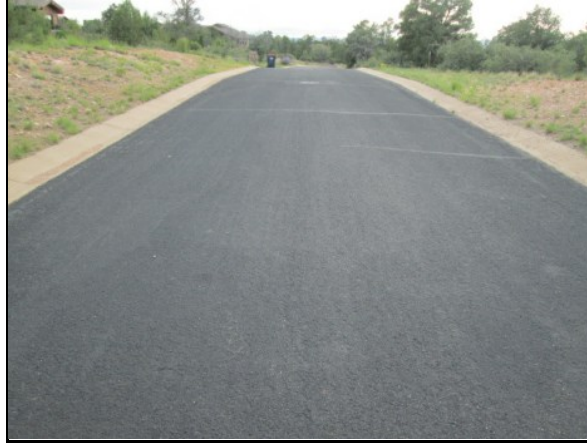
Evaluation: Surfaces appear rougher than at other areas of the community. This is possibly due to chip sealing that was applied in the past. There does not appear to be significant wearing or deterioration though. Life span is based on periodically sealing and maintaining the surface.

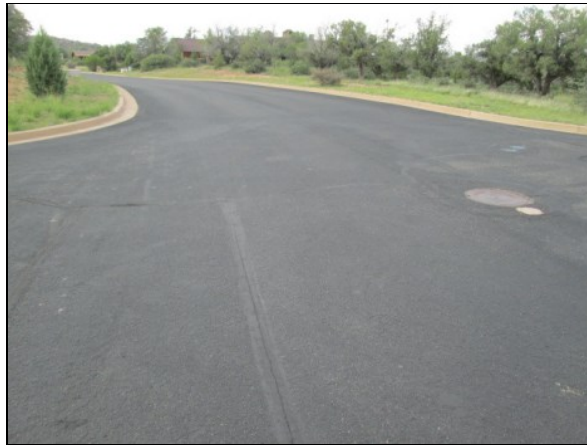
Comp #: 203 Asphalt - Seal/Repair (1A,1B,4)

Evaluation: HOA will no longer use a chip or slurry seal application, as was done in the past. Seal coat looks old and worn down. Timing of the last application for this section of the community is unknown.

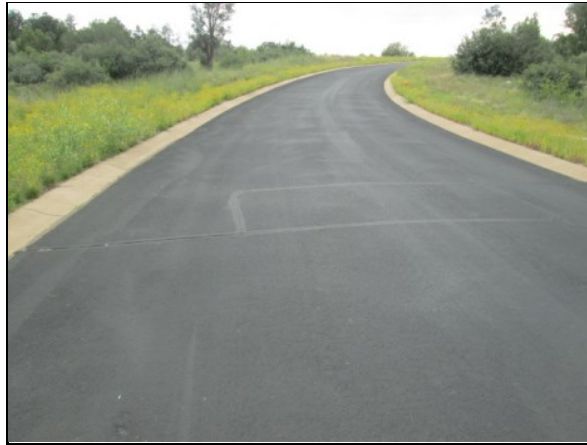
Evaluation: Surface is smooth with dark appearance. No significant cracks or deterioration. Still in good condition. Life span is based on periodically sealing and maintaining the surface.

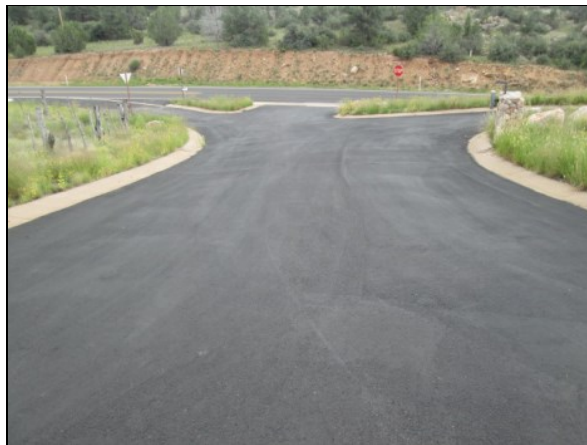
Comp #: 205 Asphalt - Seal/Repair (1C)

Evaluation: These streets were seal coated not long before our 2016 inspection. Surfaces were dark and in good condition.

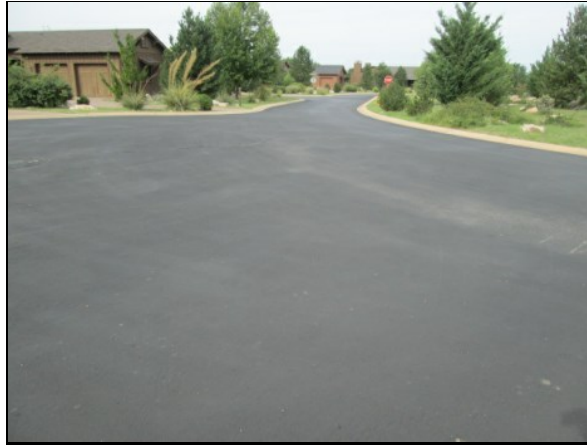
Evaluation: Surfaces appear to be smooth and in good condition. Overall, minimal signs of cracking or surface deterioration with some limited exceptions where large cracks are visible. Life span is based on periodically sealing and maintaining the surface.

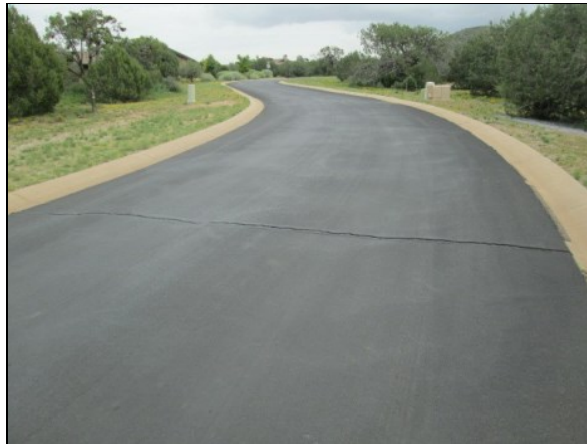
Comp #: 207 Asphalt - Seal/Repair (2,3,27)

Evaluation: These streets were seal coated not long before our 2016 inspection. Surfaces were dark and in good condition.

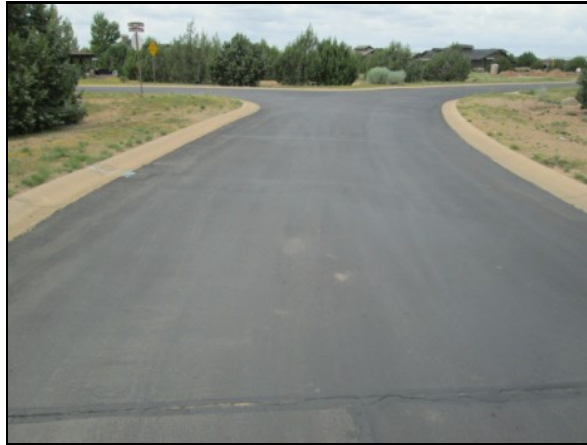
Evaluation: Surfaces are generally smooth and look good overall. Some spots with more consolidated cracking noted. Life span is based on periodically sealing and maintaining the surface.

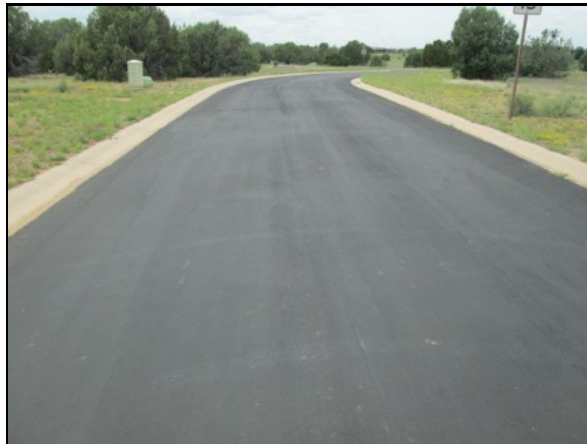
Comp #: 209 Asphalt - Seal/Repair (5,8,9)

Evaluation: These streets were seal coated not long before our 2016 inspection. Surfaces were dark and in good condition.

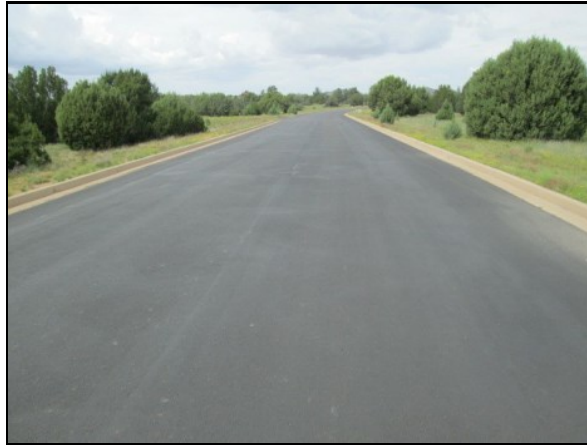
Evaluation: Generally smooth and in good condition. Minimal cracking noted. Life span is based on periodically sealing and maintaining the surface.

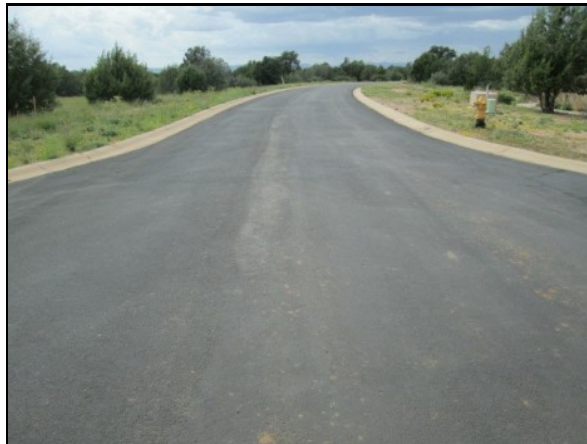
Comp #: 213 Asphalt - Seal/Repair (10)

Evaluation: These streets were seal coated not long before our 2016 inspection. Surfaces were dark and in good condition.

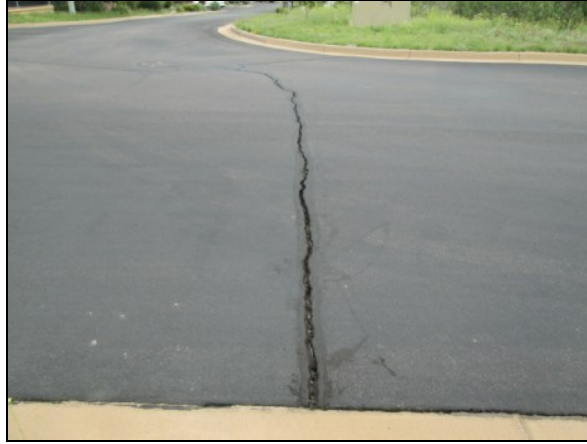
Comp #: 250 Asphalt - Crack Seal

Evaluation: There is a large quantity of pavement throughout this community. Large cracks should be filled/sealed regularly to prevent water intrusion in to the pavement base. This component funds an annual allowance to crack fill where needed throughout the community.

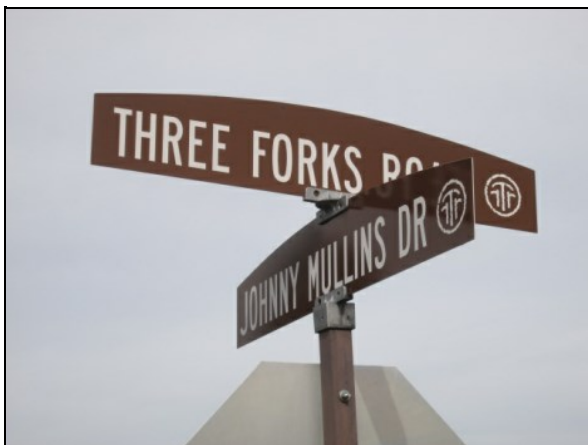
Comp #: 300 Street Signs - Replace

Evaluation: Street signs appeared to be in decent shape at the time of inspection but were replaced not long after. Expected to be in good condition. Photo in this report shows the original signs. Repairs and individual sign replacements should be funded as an Operating expense when needed.

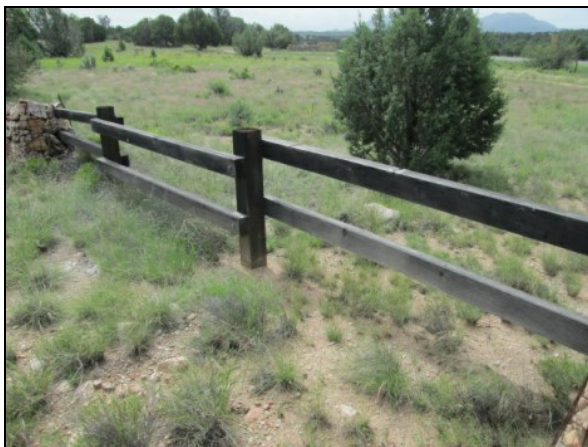
Comp #: 505 Split Rail Fence - Replace

Evaluation: These are wood split rail fences. Sections of fence are connected by stone basket columns. Fence appears to be securely mounted and holding up well for its age. Some areas are split and cracked. Most of the wood is not stained or treated, and there is no expectancy to do so. Funding does not include replacement of the stone columns. They should be repaired as a maintenance project when needed.

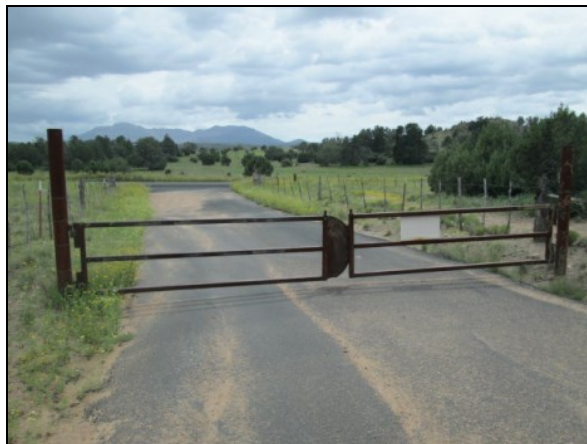
Comp #: 524 Emergency Gates - Replace

Evaluation: These gates are locked and not used. This is for emergency access only. Long life expectancy under normal circumstances. Recommend budgeting to replace at some point in the future.

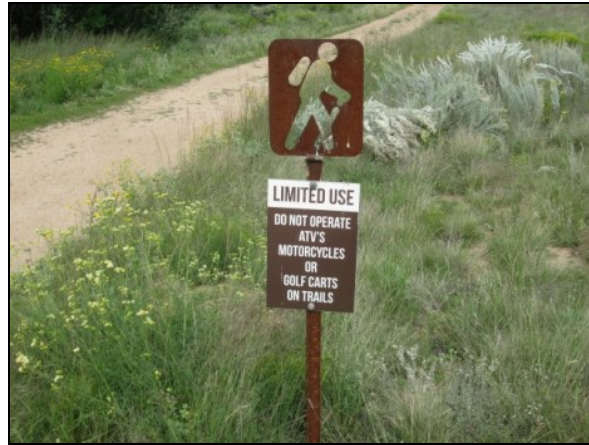
Comp #: 550 Trail Signs - Replace

Evaluation: Signs are metal cut-out style with a rust finish. They are mounted to a metal post with another plastic sign. Total quantity is currently unknown. Repair or replace individual signs as a maintenance expense. This component funds complete replacement eventually to maintain uniformity throughout the community.

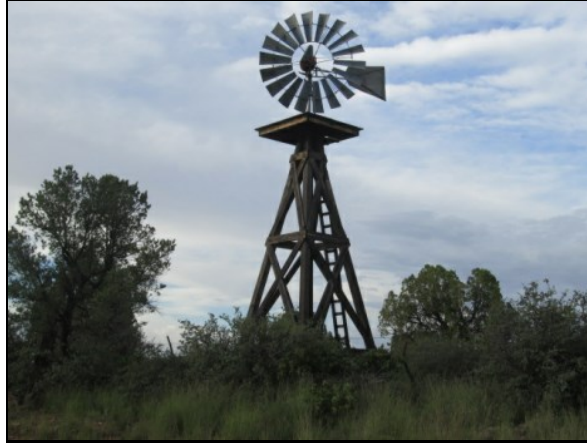
Comp #: 560 Windmill - Replace/Rebuild

Evaluation: Windmill has a wood structure with a metal fan and motor. This component funds to rebuild the entire wood structure and replace the metal components. There is a possibility the metal will not need replacing if well maintained, which would reduce the cost. Wood appears old and has not been stained or maintained.

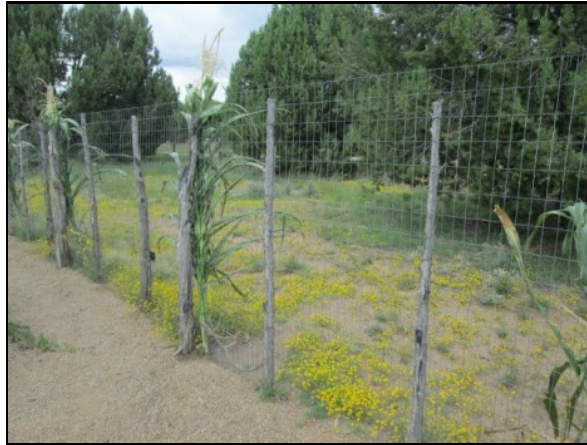
Comp #: 430 Garden Fence - Replace

Evaluation: Garden fence installed at the time of inspection (and picture here) was the same type of wire fence installed at the dog park. It has since been replaced.

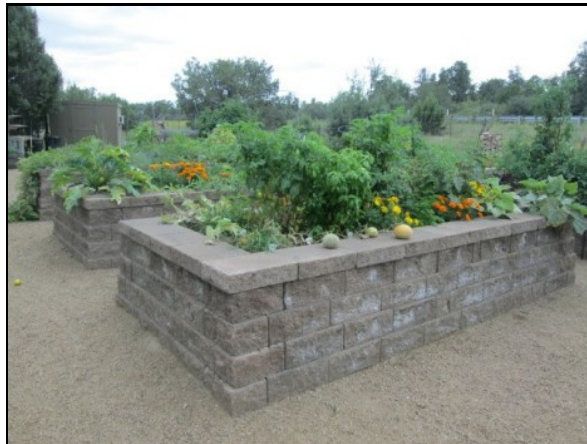
Comp #: 433 Garden Beds - Replace

Funded?: No. This component has an extended life span with no expectancy to replace.

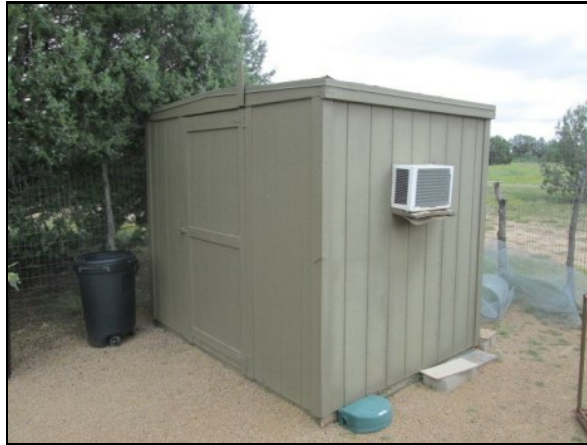
Comp #: 436 Garden Shed - Replace

Evaluation: This is a 6' x 8' shed with 7' high wood walls. Structure appears to be in good condition. Repaint periodically as a maintenance project or include with the gazebo.

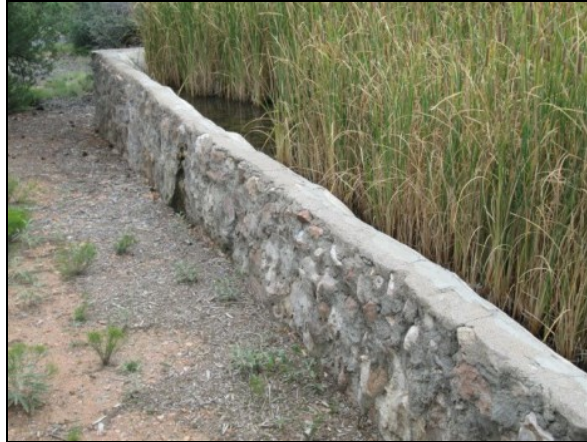
Evaluation: This is a concrete pool/pond structure. It reportedly has an epoxy based plaster surface. Most of the surface is covered with rocks and plants, so it is not visible to inspect. Resurfacing this pool should be planned at some point in the future. At least one sign of leaking at the time of inspection.

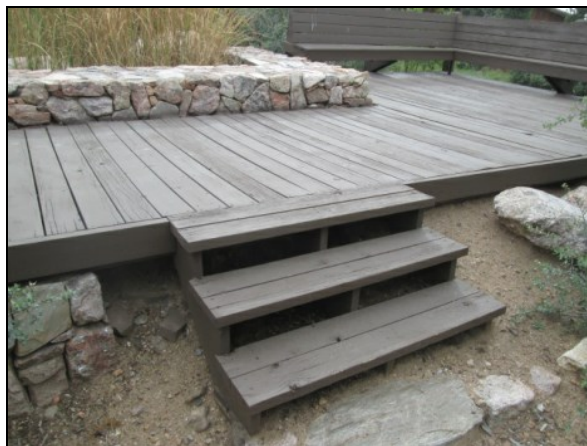
Comp #: 452 Pond Deck - Replace

Evaluation: Wood looks aged and weathered. There are lots of surface cracks and splits visible. Still structurally intact, but replacement should be anticipated eventually.

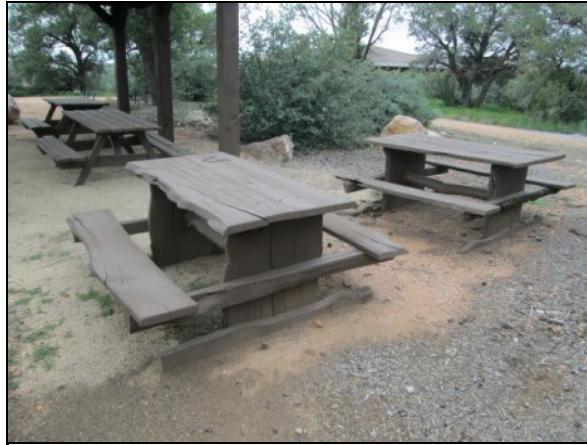
Comp #: 456 Park Furniture - Replace

Evaluation: These are wood picnic tables. Generally intact and still in good shape. One was partially damaged though.

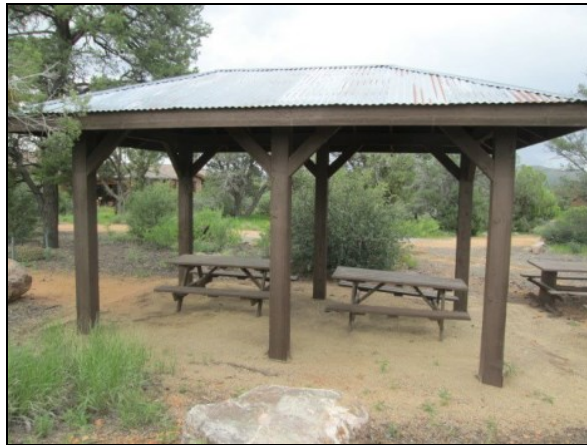
Comp #: 460 Gazebos - Replace

Evaluation: These are 20' x 14' wood structures with corrugated metal roofs. Wood appears intact and still looks fine. This component funds to replace or significantly rebuild the structures.
